Guinea Residents of Gloucester County Elevate Homes after Isabel

Full Mitigation Best Practice Story

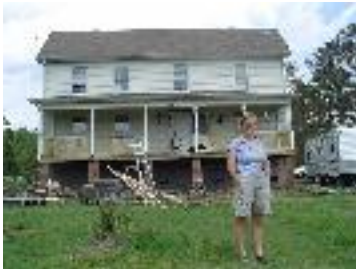
Bain Schultz's home is elevated following Hurricane Isabel

To comply with Gloucester County's floodplain ordinances, the Schultz home was elevated over a crawl space with the first floor above the established Base Flood Elevation. “It would have been irresponsible if we didn't elevate,” said Bain Schultz.

A new concrete block foundation wall includes the required flood vents. The vents allow for the free passage of water automatically in both directions without human intervention. The bottom of the openings are no higher than one foot above grade underneath the flood vents.
